Circular CAM 04/2020

Subject: **Safety Bulletin LU-MA-SB/2020-001**

SAFETY BULLETIN LU-MA-SB/2020-001

The ongoing investigation of the sinking of the vessel Bourbon Rhode on 26 September 2019 in the Atlantic Ocean during a transit voyage from Las Palmas to Guyana has highlighted a safety issue that requires an immediate safety action.

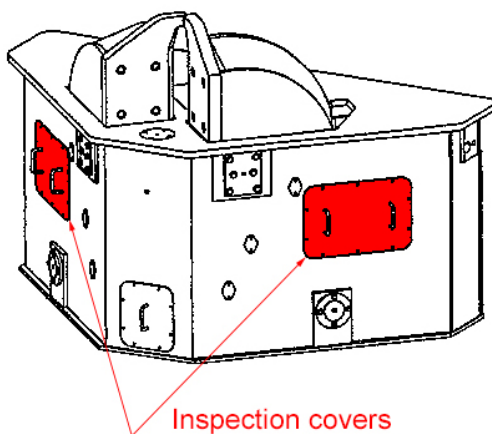
The Bourbon Rhode, an oceangoing anchor handling tug, was equipped with a system called shark jaws¹, installed in the aft Z-Drive compartment, to secure chains or wires during anchor handling operations. During operation, water from the deck can enter the watertight housing frame, which has three drain fittings at the bottom plate. When not in use, the shark jaws are lowered into the housing frame and are flush with the deck. In lowered position, gaps around the shark jaws allow water to enter the housing frame.

Figure 1. - Shark jaws housing frame²

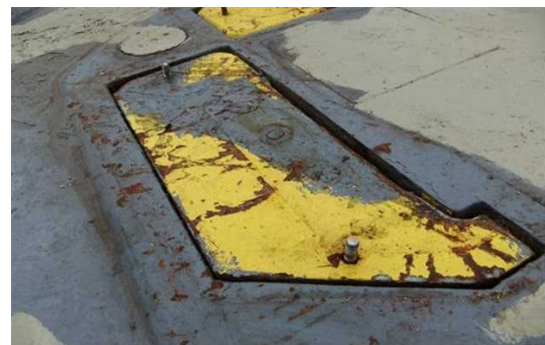
Figure 2. - Retracted shark jaws on Bourbon Rhesos³

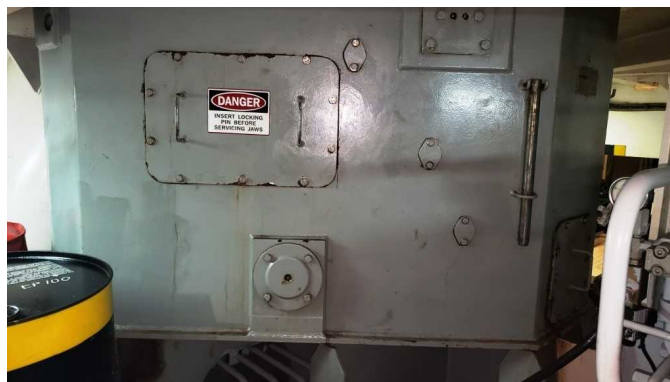
Figure 3. – Shark jaws inspection cover on Bourbon Rhesos⁴

Over time, the inspection covers of the shark jaws housing frame on the Bourbon Rhode have lost their watertight properties. The water leaking through the gaps between the housing frame and the inspection covers was collected in the bilge well at the bottom of the Z-Drive compartment and could be pumped out by activating the bilge pump system.

The investigation has shown that under unfavorable circumstances and in combination with other safety-related factors that will be developed in the final report, the water quantity penetrating the compartment is likely to increase up to a point where, when unnoticed or unattended for a certain period of time, an unsafe condition may develop and lead to a major flooding with subsequent foundering.

During the investigation, further analysis by the operator has identified other anchor handling vessels in his fleet with leaking inspection covers of the anchor handling systems⁵. This shows that the compromised watertightness of the anchor handling systems equipped with this type of inspection covers is not an isolated safety issue, but is likely to be encountered at a systemic level. This latent condition led to the issuance of the present safety recommendation.

The Administration of technical investigations advises all operators of vessels equipped with the Plimsoll Smith Berger Hydraulic Shark Jaw system P3679-350MTTA or anchor handling systems with similar designs of the inspection covers to implement in the vessel operator's Safety Management System a standard procedure for tasks requiring the opening of the inspection covers of the anchor handling system housing frame.

- Instructions for the appropriate sealing method when installing the inspection covers to ensure the watertightness of the anchor handling system housing (e.g. application of silicone sealant, installation of gasket);

- Instructions for testing the watertightness of the anchor handling system after completion of the works and installation of the inspection covers (e.g. flooding of anchor handling system housing frame with closed drainage by use of fire hose).

- Maintenance actions to prevent a degradation of the inspection covers and securing devices, which could compromise the watertightness of the anchor handling system;
